NATIONAL TRANSPORTATION SAFETY BOARD

AIRFRAME AND ENGINE EXAMINATION SUMMARY

WPR16LA106

| Aircraft: | Boeing B75-N1, N56200 |

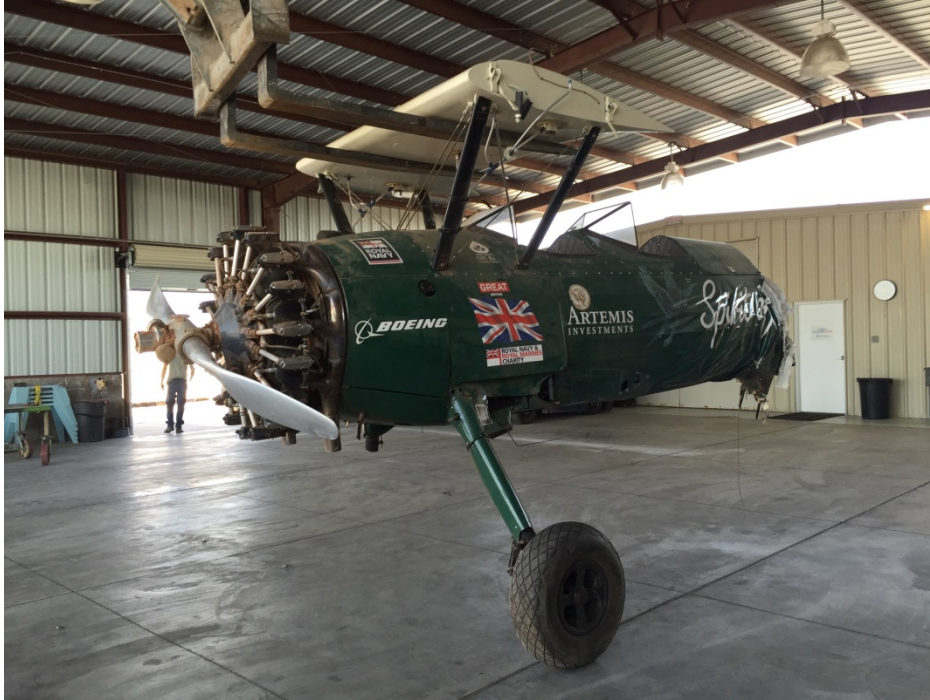
Examination of the recovered wreckage revealed that the upper and lower wings were removed by the wreckage recovery company to facilitate wreckage transport. The empennage and right gear leg were also separated from the fuselage. The engine remained attached to the fuselage via its mounts. The fuselage was hoisted by a forklift and the right gear leg was subsequently removed. Throttle, mixture, and propeller control continuity was established from the rear cockpit controls to the engine.

Photo 1: The recovered airframe.

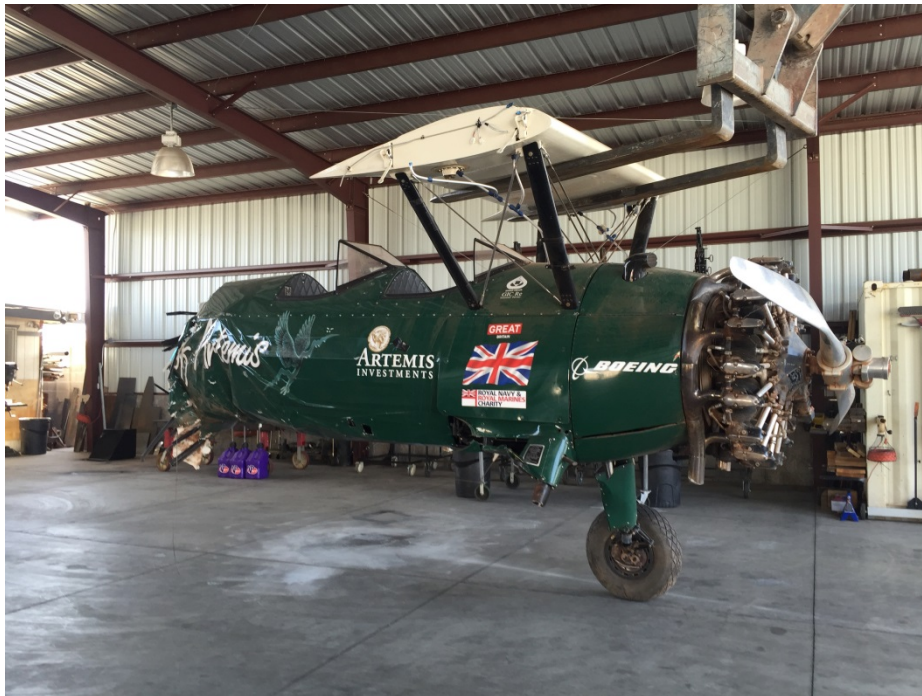
Photo 2: The recovered airframe.

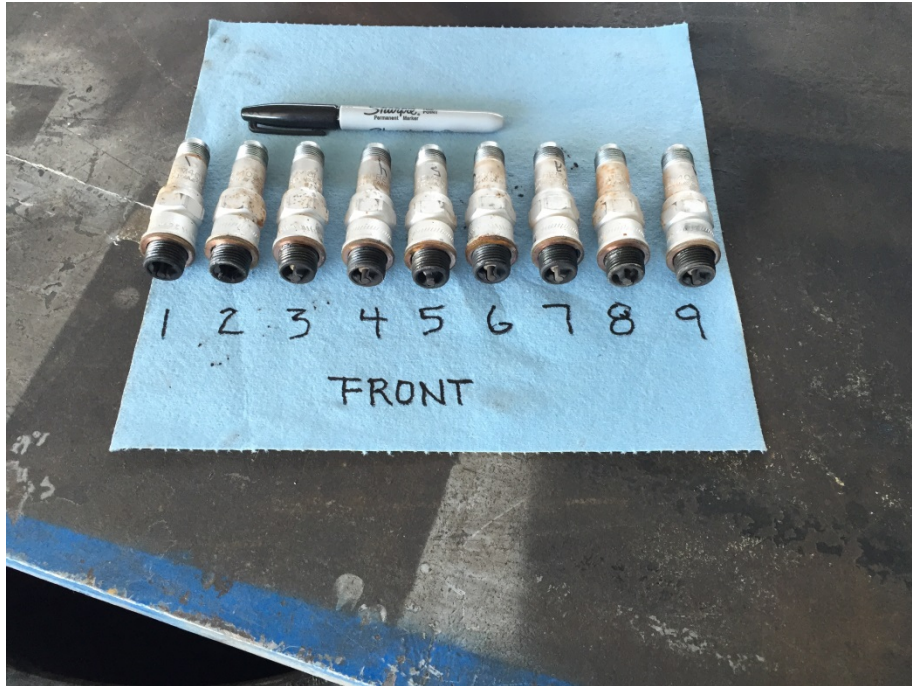
The front spark plugs were removed and examined. All 9 spark plugs were intact and undamaged. The number 1 and 2 spark plugs exhibited black deposits within the electrode area and the remaining spark plugs exhibited gray deposits within the electrode area. All engine accessories remained attached to the engine and exhibited no damage. The carburetor was intact and all linkages were secure. The carburetor fuel screen was removed and a gray / tan liquid was drained from the carburetor. The fuel screen was free of debris. The liquid smelled similar to 100 Low Lead fuel, and tested negative for water using water finding paste. The air filter was removed and a red dirt substance was observed within the housing, however, the air filter element appeared to mostly free of debris. The gascolator screen and bowl was free of debris.

Photo 3: Front Spark Plugs

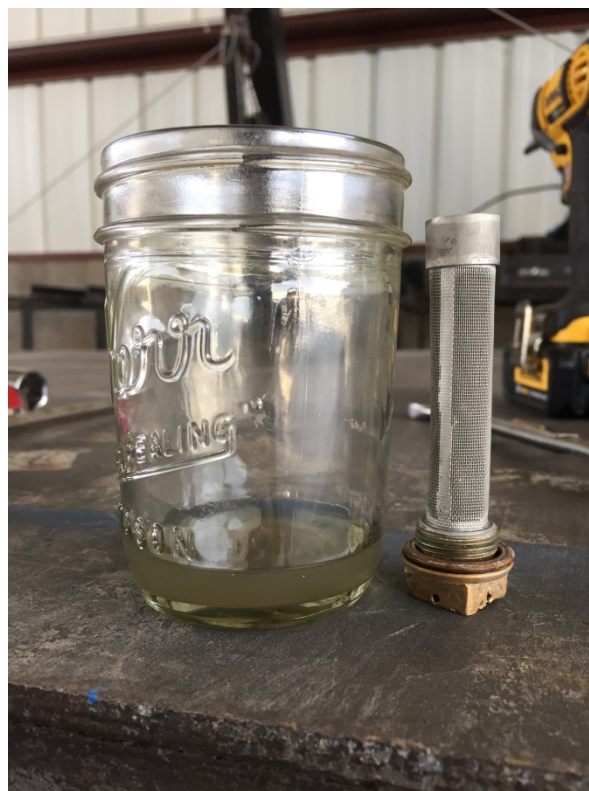
Photo 4: Liquid removed from the carburetor and carburetor screen.

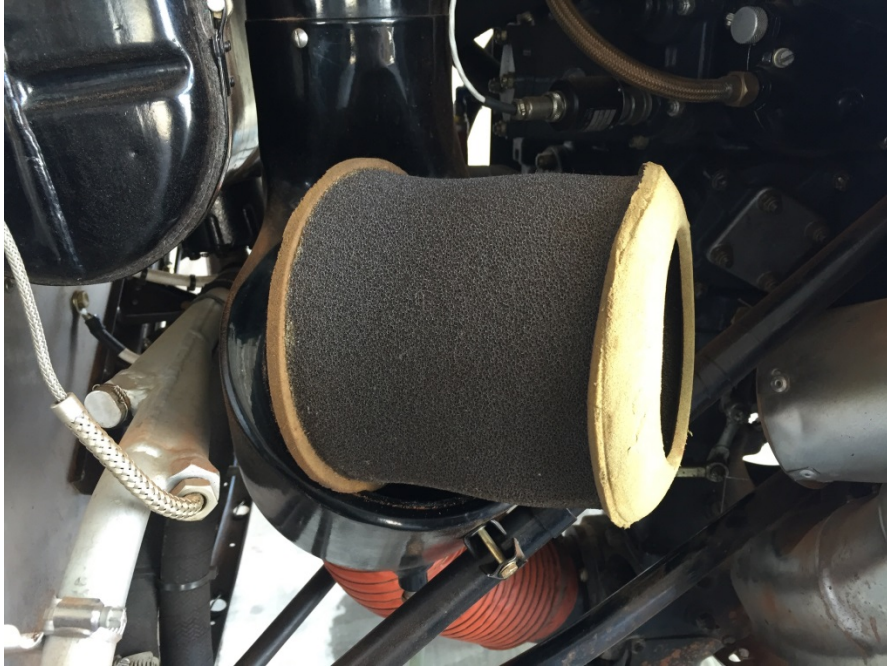
Photo 5: Air Filter

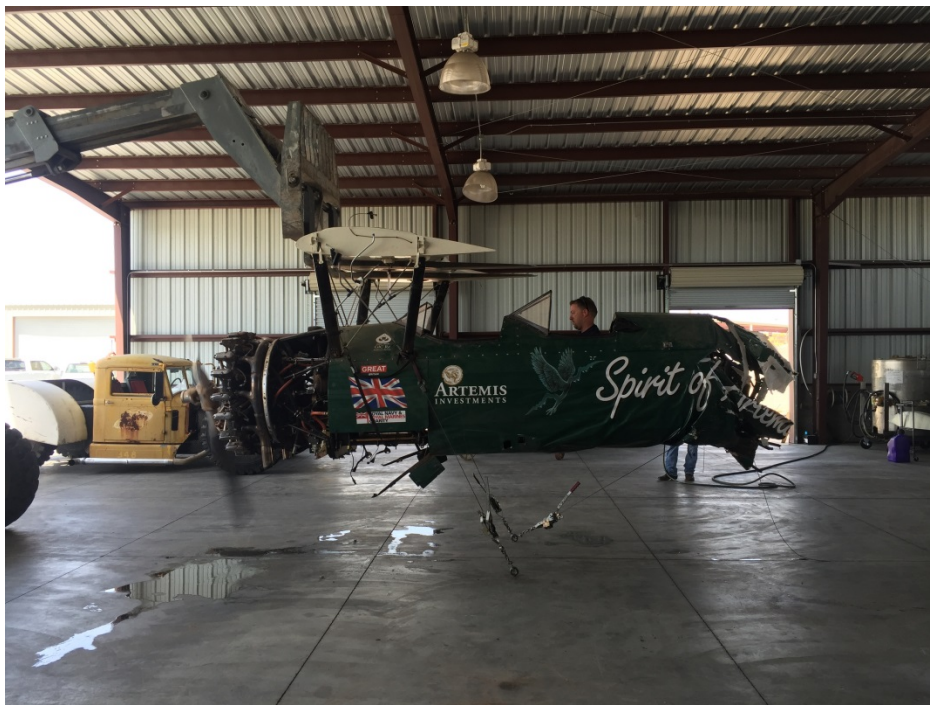
The spark plugs and carburetor fuel screen were reinstalled. About 8 gallons of fuel was added to the center wing fuel tank. The engine was primed using the airframe fuel pump and subsequently started. The engine was run for about 10 minutes at various power settings. During the engine run, a maximum power setting of 2,200 rpm and 28 inches of manifold pressure was obtained. A magneto test was performed at 1,500 rpm with a drop of about 75 to 100 rpm noted. The engine was manually shut off using the mixture.

Photo 6: Engine run
